HAI AL IMAN CLINIC  
HILLA, IRAQ

**SIGIR PA-05-017**  
**MARCH 7, 2006**

## **Hai Al Iman Clinic in Hilla, Iraq**

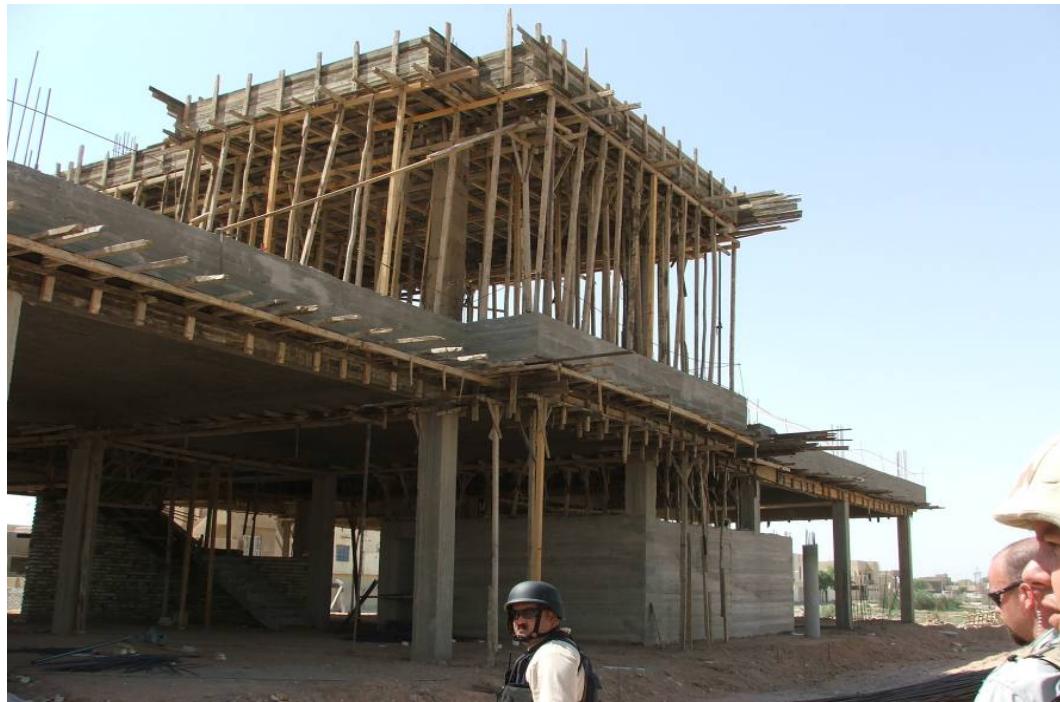
Significant work underway included the construction of the structural concrete elements of the facility, specifically the ground floor columns, ground floor structural beams, ground floor ceiling slab, interior stairwell, X-ray room walls, first floor structural beams, first floor columns, and first floor ceiling slab. The contract and design required cast in-place reinforced concrete structural beams, columns, and slabs. At the time of the site visit, most of the concrete for these items had been poured. Either the formwork had been removed or formwork was in-place pending curing of the concrete. Due to the short duration of the site visit and the first floor form work still in place, only selected areas of the construction could be evaluated. For an illustration of ground floor and first floor construction, see Site Photo 1.

**Site Photo 1. Ground Floor and First Floor Construction**

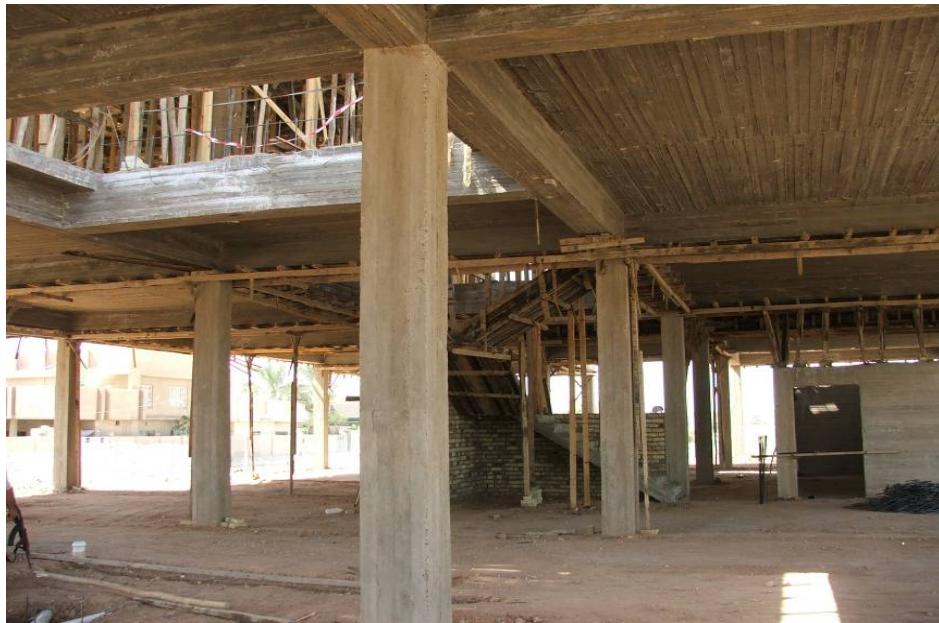
At the time of the site visit, all ground floor columns and ceiling beams had been completed and most of the formwork removed. We observed only a portion of the columns, ceiling beams, and ceiling slab. We identified concrete segregation, voids, and re-bar exposure on the surface of the load-bearing reinforced concrete ceiling beams. We observed no significant discrepancies on the columns and ceiling slab. For an illustration of interior concrete columns and a ground floor slab, see Site Photo 2. For illustrations of the first floor ceiling concrete beam, see Site Photo 3 and Site Photo 4. This concrete beam does not meet design specifications listed in the design for minimum concrete cover for reinforcement placed in “cast in place” concrete as it applies to “concrete beams not exposed to weather or in contact with the ground”.

**Site Photo 2. Interior Concrete Columns and Ground Floor Ceiling Slab**

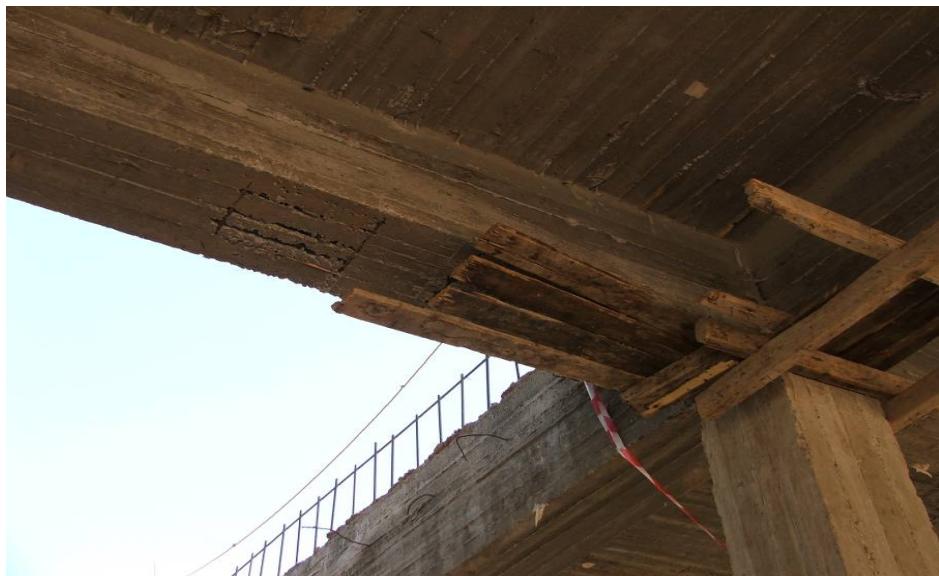
**Site Photo 3. First Floor Ceiling Concrete Beam**

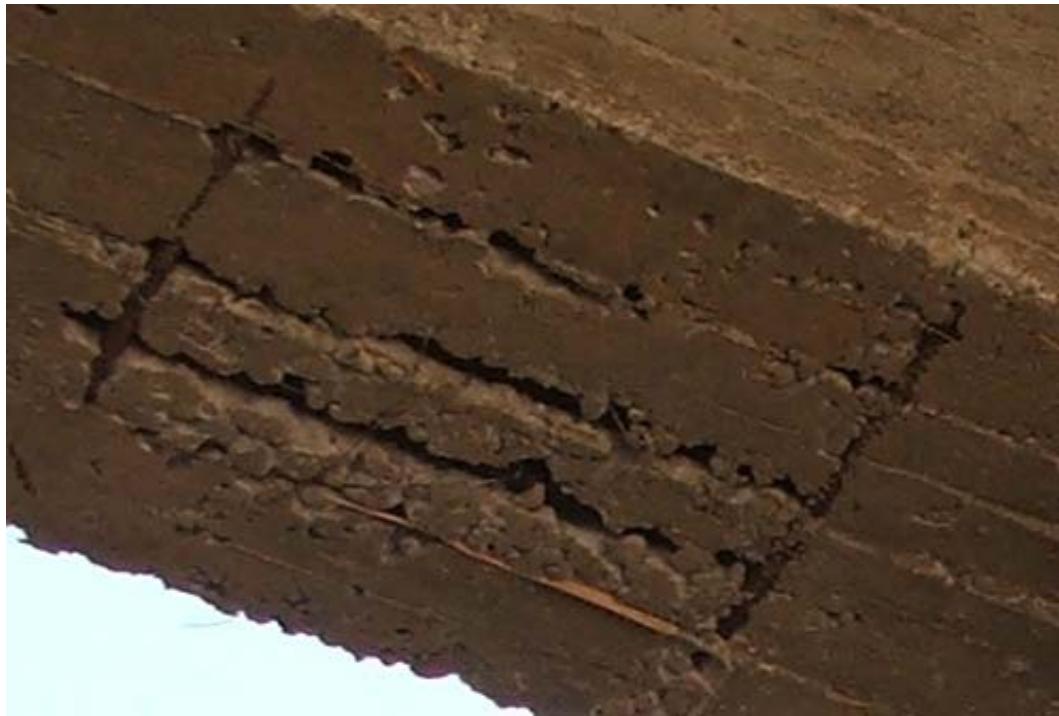
**Site Photo 4. Close-Up View of Site Photo 3**

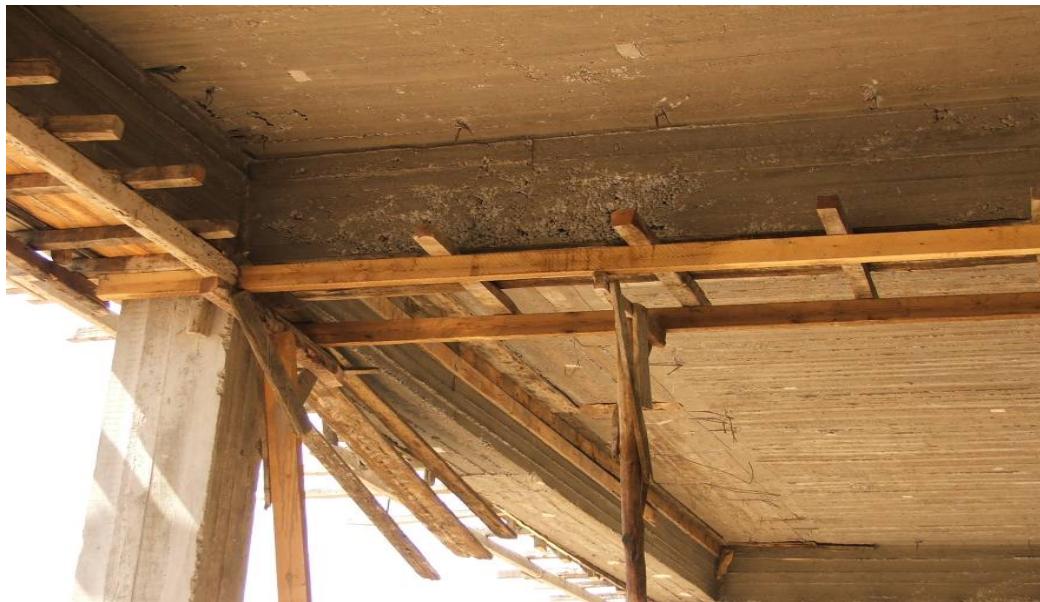
For an illustration of concrete segregation on the side of a load-bearing reinforced ceiling beam, see Site Photo 5 and Site Photo 6. The required design strength of this beam may not be obtained due to segregation of material during the concrete pour.

**Site Photo 5. First Floor Ceiling Concrete Beam with Concrete Segregation**

We recommend the contractor evaluate concrete deficiencies and complete corrective actions. Corrective action proposal by the contractor and approval by the PCO or the USACE is advised to correct this deficiency.

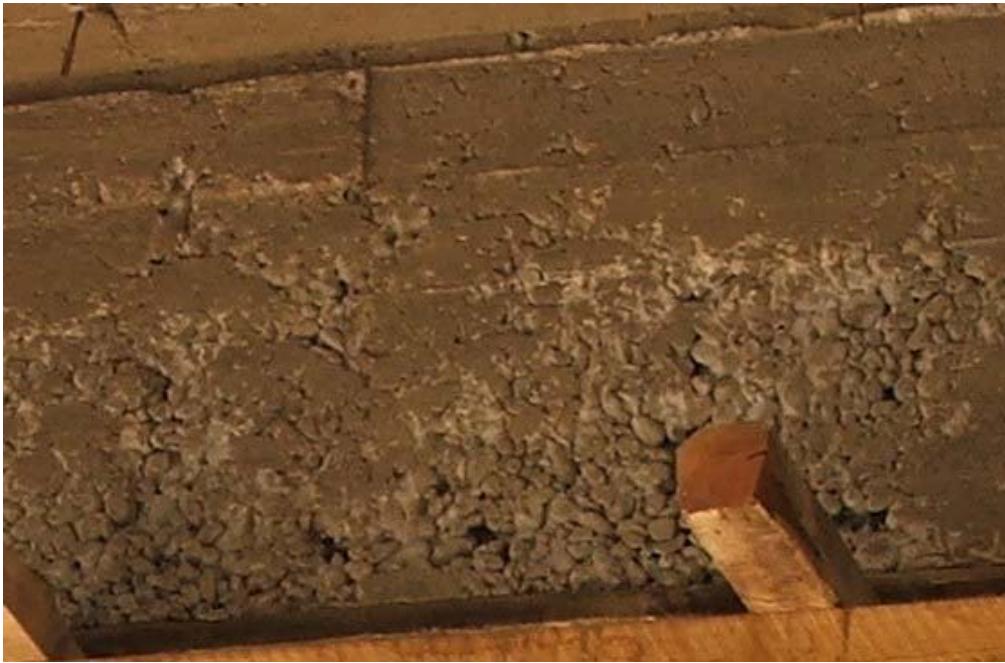
**Site Photo 6. Close-Up of Site Photo 5**

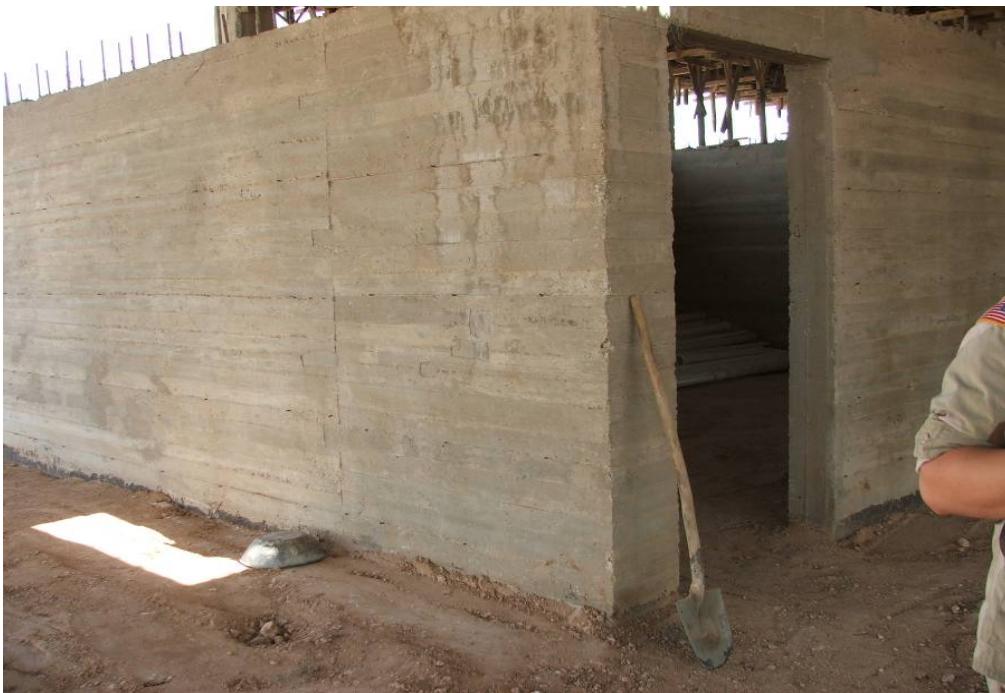
The design required the construction of a “cast in place” reinforced concrete-walled room to be utilized for the operation of x-ray equipment. During our site visit, we verified the walls of the x-ray room were complete, although the reinforced concrete slab floor had not been installed. We identified no deficiencies during our site visit. For an illustration of the x-ray room exterior walls, see Site Photo 7.

**Site Photo 7. X-Ray Room Concrete Walls**

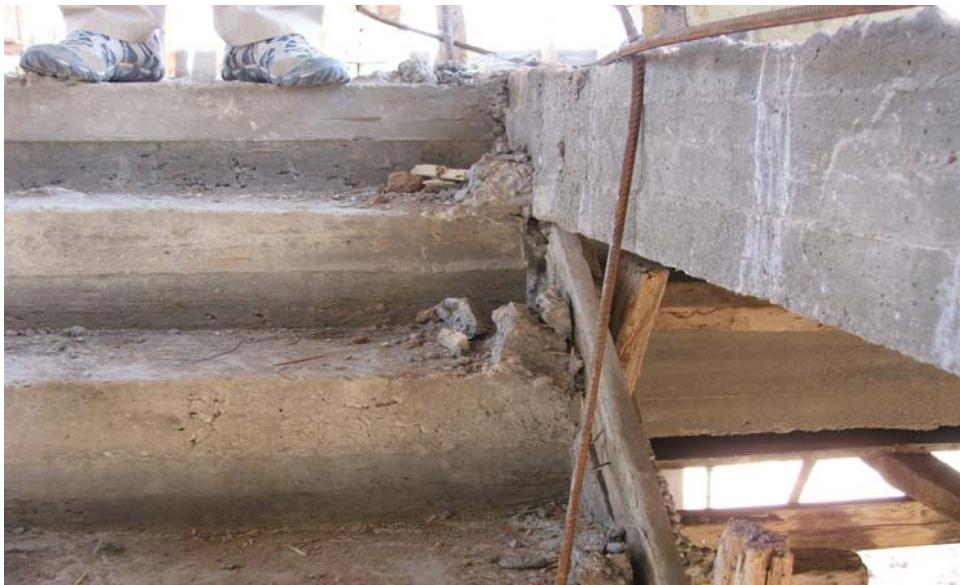
The project design drawings required the construction of one stairwell from the interior ground floor to the first floor, consisting of “cast in place” reinforced concrete. During our site visit, we verified the concrete stairwell was in place, although the workmanship of the concrete placement was poor. Concrete overflow was located near the corners of the stairs (Site Photo 8), the surface was uneven, and the lip of the stairs was cracked (Site Photo 9). During its construction, the stairwell appears to have been utilized by the construction crews to move personnel and equipment from the ground floor to the first floor. Some of the damage may be attributed to construction activities; however, the majority of the deficiencies appeared due to poor workmanship.

**Site Photo 8. Ground Floor to First Floor Stairwell**

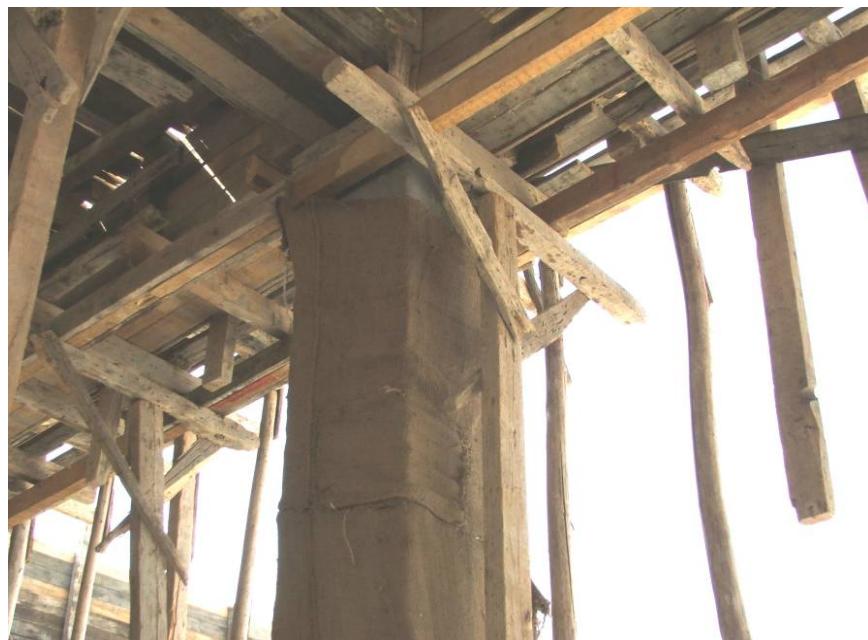
At the time of our site visit, the first floor columns, ceiling beams, and ceiling slab had been completed; however, the formwork had not been removed. In place formwork prohibited an inspection of the concrete surface on the first floor. For an illustration of the first floor column wrapped in burlap as required during curing procedures, see Site Photo 10. For an illustration of the ground floor roof section, see Site Photo 11.

**Site Photo 10. First Floor Column with Burlap Wrap**

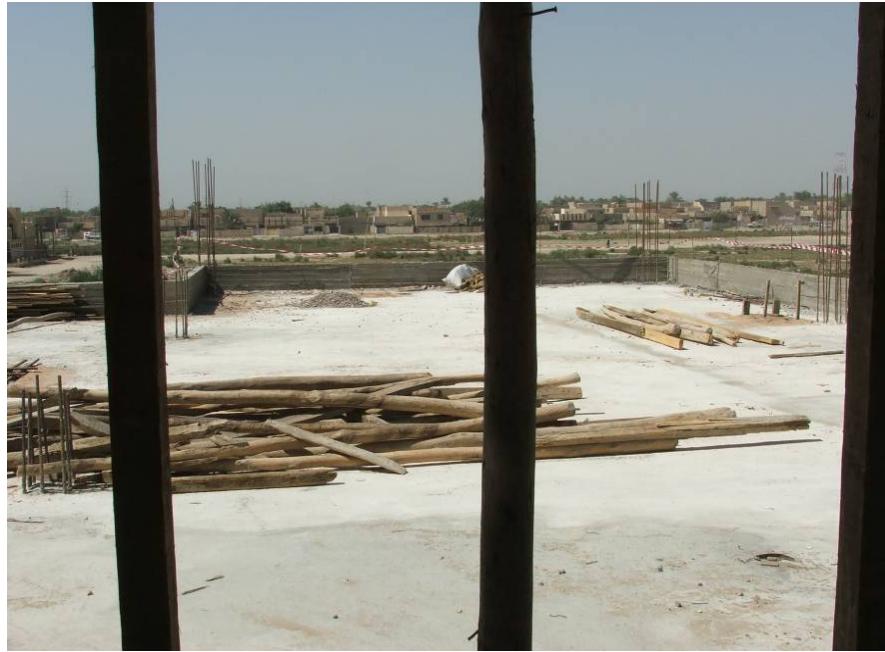
**Site Photo 11. Ground Floor Roof Section**
